**GOVERNMENT OF THE DISTRICT OF COLUMBIA**  
Department of Energy and Environment

March 22, 2018

Re: Stormwater Runoff Assessment for Lafayette Recreation Center

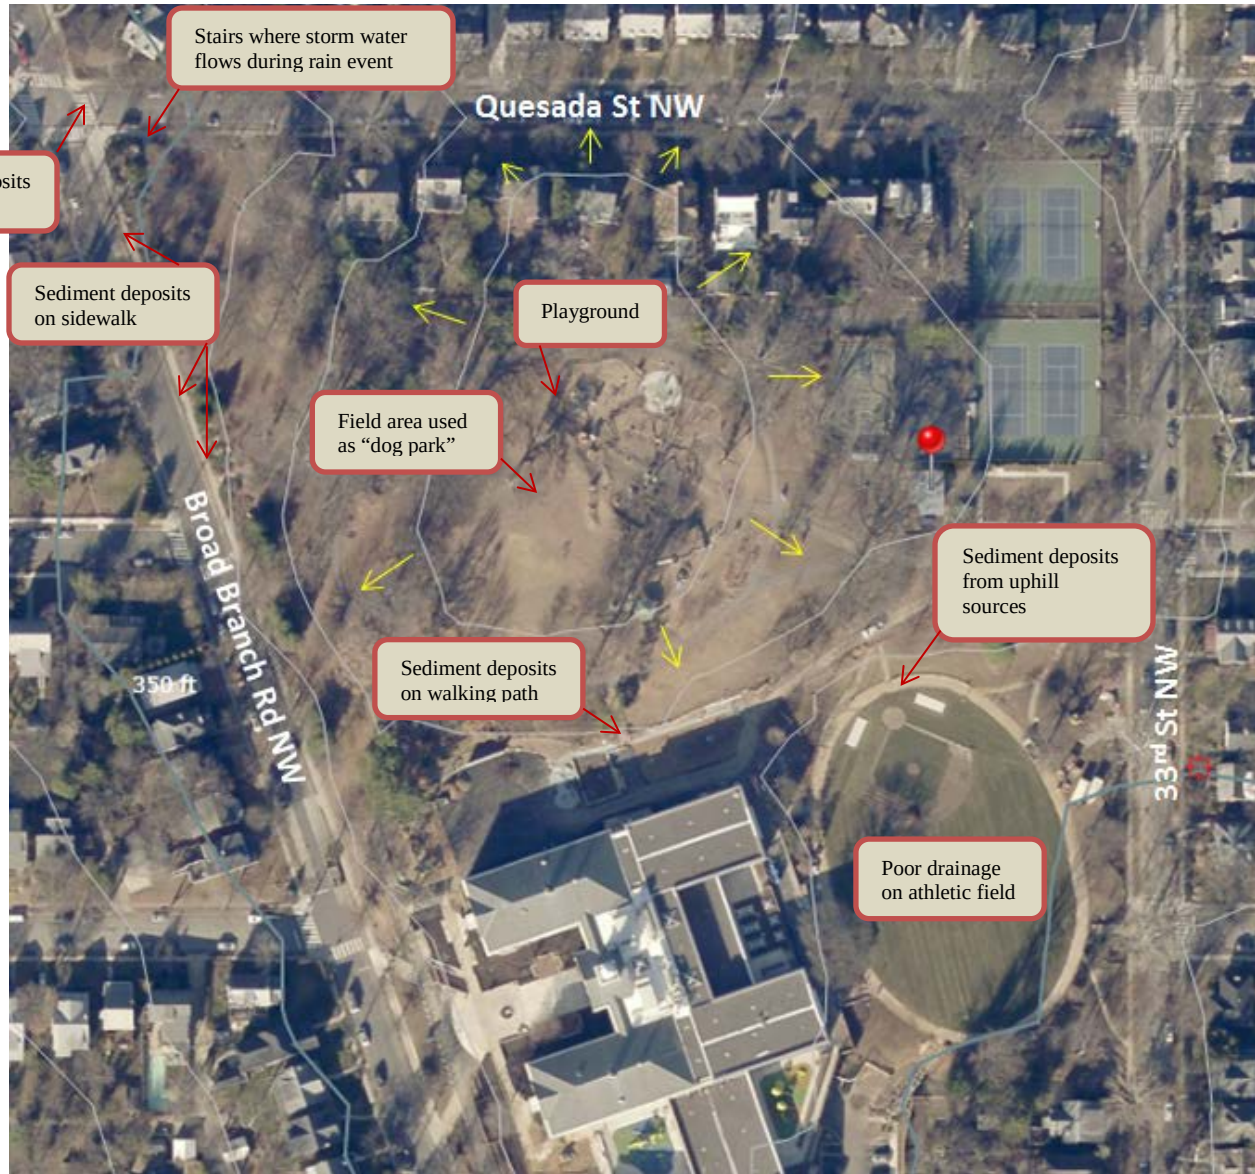
Lafayette Recreation Center is a steeply sloped site that falls within the Municipal Separate Storm Sewer System (MS4) sewershed area of the District. The highest elevation on this site is at the playground and extending to some of the field adjacent to it. These steep slopes create conditions for stormwater to gather momentum as it makes its way downhill causing erosion, stripping the trees of protective soil at the roots, creating gulleys, eroding and compromising the asphalt walking paths, and depositing sediment and debris in drainage grates throughout the site.

**Figure 1. Existing Conditions at Lafayette Recreation Center**

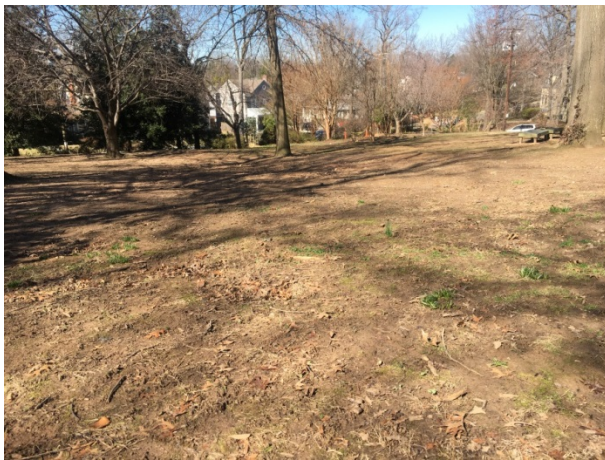
The existence of multiple mature trees throughout the site and the heavy play use of the park make it difficult for grass to grow consistently. Additionally the neighborhood frequently uses the top field as an unofficial dog park and the stakeholders expressed the residents' desire for it to remain as such.

**Figure 2. Pictures of erosion and bare ground on upper fields**

- Stakeholders indicated that the uphill area adjacent to the playground is frequently used by residents as an informal dog park and would like it to remain as such. As such, DOEE recommends the use of mulch and other natural materials to create a series of low berms that would a) slow down the stormwater, and b) direct and contain it in areas for slow infiltration and irrigation for the surrounding trees. Strategically placed berms at this uphill location would help stabilize the hillsides and help prevent the extensive erosion. This system has been used at Takoma Recreation Center, a site that had similar conditions and challenges, at a relatively low cost. It is important to note that although up to date this solution at Takoma Recreation Center has been working well, DOEE's use of this technique is fairly new and therefore still in an experimental stage.

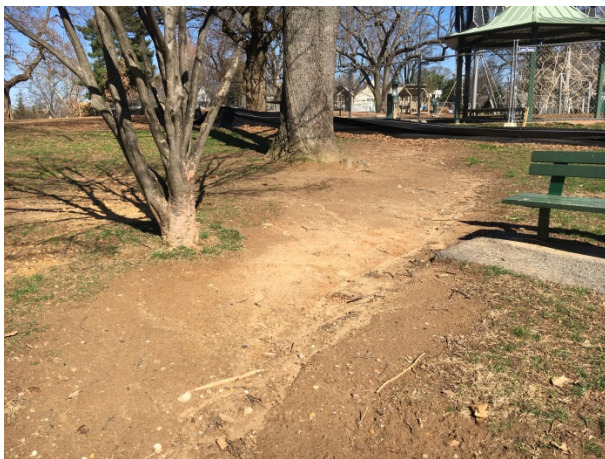
**Figure 3. Picture of a gully south of the playground**

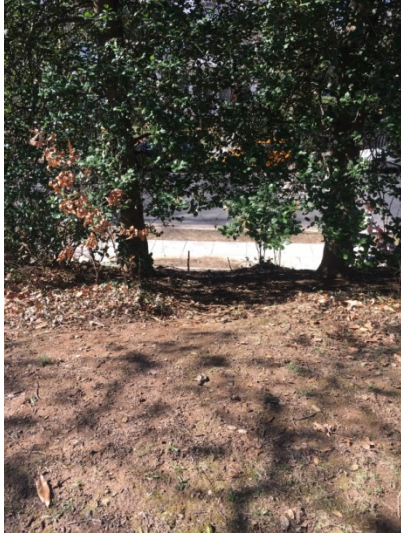
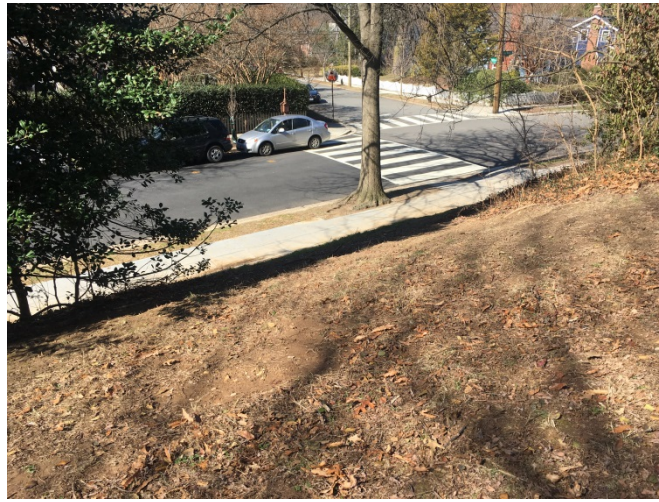
In the north-west corner of the site, this downhill rush of stormwater results in a concentrated flow at the stairs descending to the sidewalk on Quesada Street. The erosive forces of the flow result in sediment being deposited on the sidewalk adjacent to Broad Branch Road.

**Figure 4. Pictures of sediment deposit on Broad Branch Road**

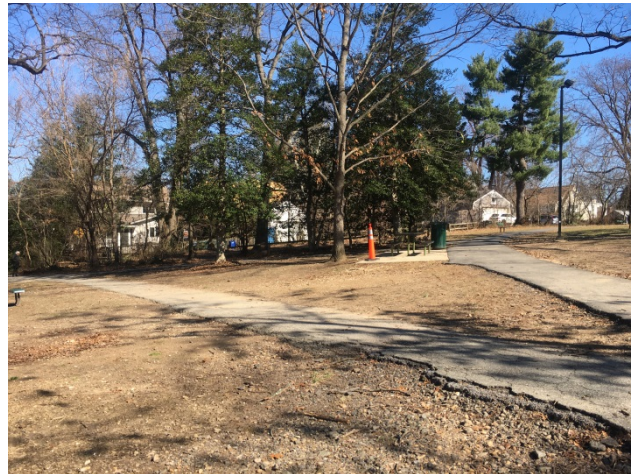
**Figure 5. Pictures of destabilized walkways**

DOEE believes that due to the large volume of stormwater that comes through this project's proposed work area, this end of pipe solution will not offset the damage to the asphalt walkways because the vast erosion uphill will quickly clog the proposed system. The solution of creating berms throughout the field, from uphill to down, will slow down the water that has been causing the destabilization of the walkways.

As an alternate project, the resident might work with the landscape designer to employ DOEE's proposed mulch and berm solution at a smaller scale. Mulching the area adjacent to the walking path and building low berms perpendicular to the flow path may help mitigate future damage to the walking path and offer protection and irrigation for the trees in the project area. Please note that this would only be a temporary solution since the practice would be demolished when a comprehensive solution to the area is being worked on.

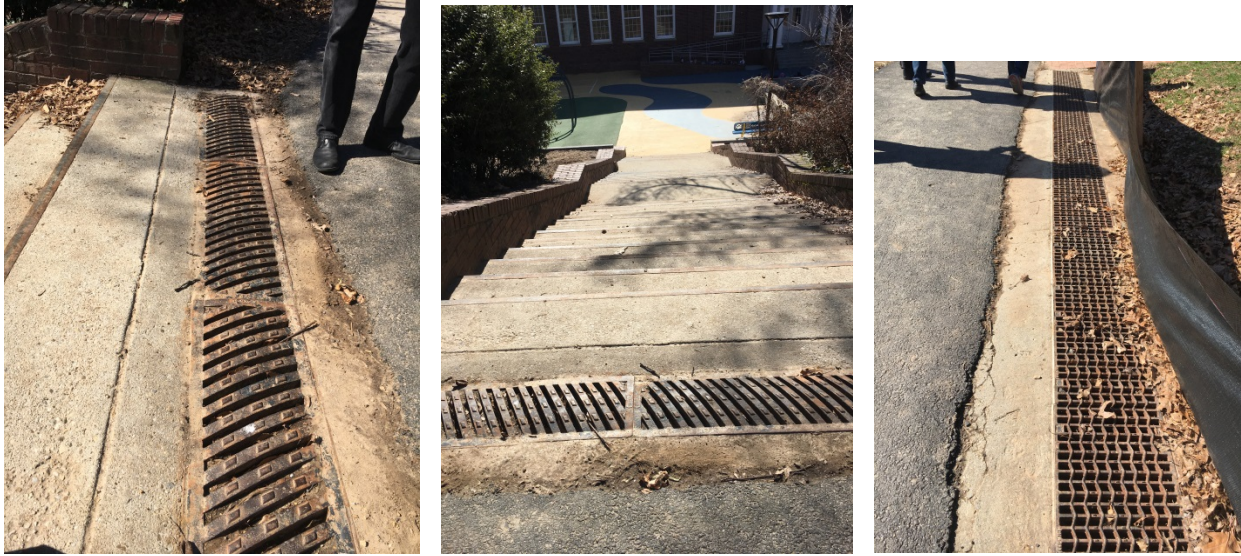
**Figure 6. Pictures of sediment and debris deposit at drainage grates**

DOEE proposes that DGS clean out the drainage grates to get them back to functioning order in conjunction with uphill site stabilization to prevent further sediment clogging from occurring.

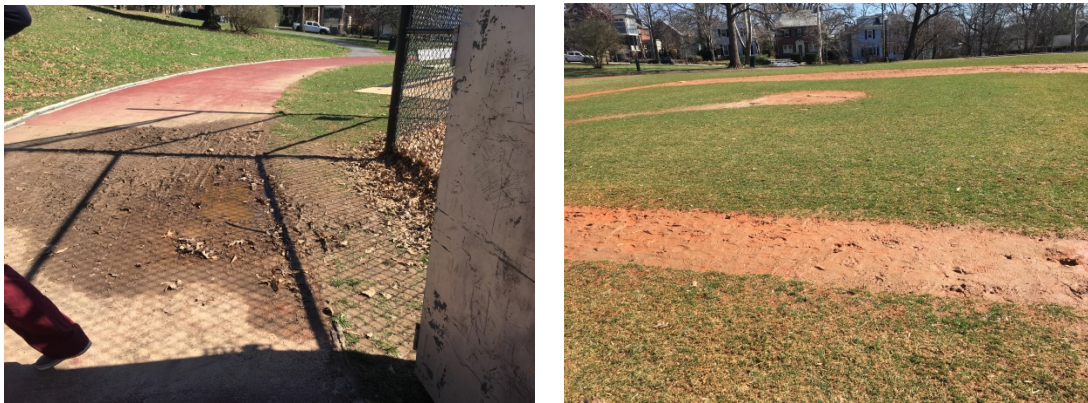
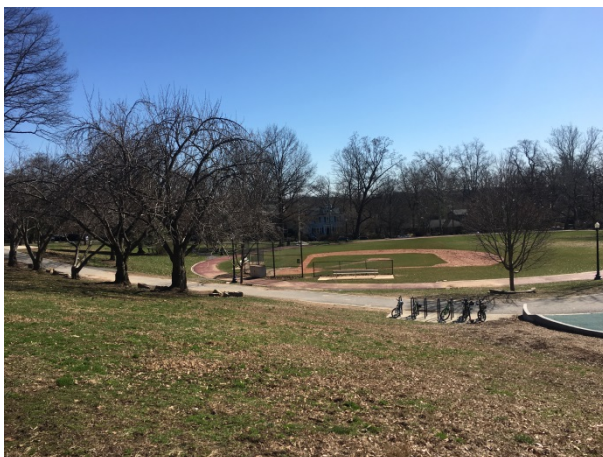
On the athletic field, drainage is poor and the field remains soaked well after a rain event.

**Figure 7. Pictures of sediment deposit on athletic track, the saturated athletic field and the driveway which stakeholders desire to be removed.**

However, as the site visit revealed, the northern half of the field remained saturated over 40 hours beyond a storm event, and again sediment had accumulated on the north track abutting DPR land. DOEE suggests that stakeholders have a conversation with DCPS to address these concerns. Possible areas for review may include verification of the grading on that drainage area to ensure that it was indeed sloped sufficiently enough to convey stormwater towards the disconnection per the design intention.

A cleaning of the trench drains should alleviate the problem of the uphill stormwater, but this would have to be done periodically.

Lastly, DOEE notes that based on our assessment above, at least some of the problem on the athletic field will persist unless the site uphill is stabilized. DOEE's suggestion of implementing a bioretention in the place of the driveway should aid towards this solution.
